## **PYROGEN SUCCESSFULLY EXTINGUISH FIRE IN A COMMUNICATIONS ROOM AT A RENOWNED SHOPPING COMPLEX IN KL, MALAYSIA**

### **1. Introduction:**

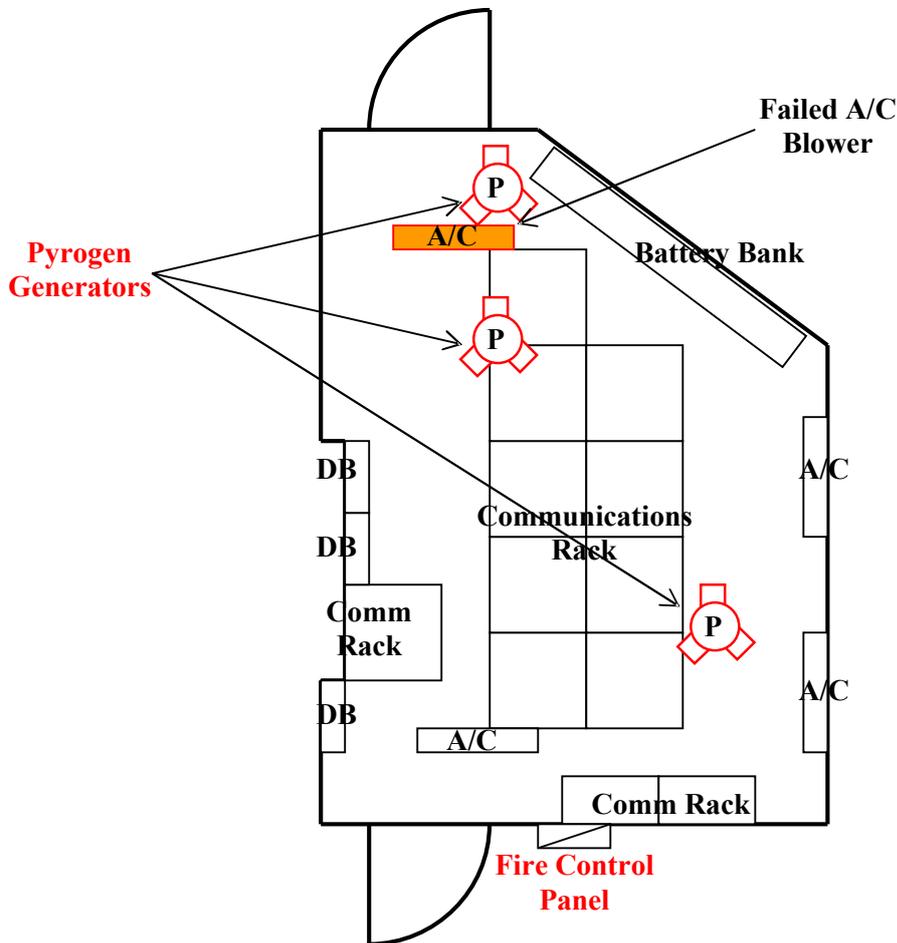
**Layout Plan of Communications Room**

The system installed for this room is a conventional double-knock configuration which uses smoke and heat detectors connected to a Pyrogen Fire Alarm and Discharge Panel. “Evacuate” flashing lights are installed on the inside of the room to provide visual indication of the location of exit points and on the outside of the doors are installed “Green and Red” flashing lights to indicate if the system has been activated or not.

Audible notification of alarm is provided by means of an electro-mechanical bell and an electric buzzer at the Fire Control Panel. The system is set-up to provide a mandatory 30 seconds delay after both the smoke and heat detectors are activated to evacuate the room before the system energises the Pyrogen generators to discharge.

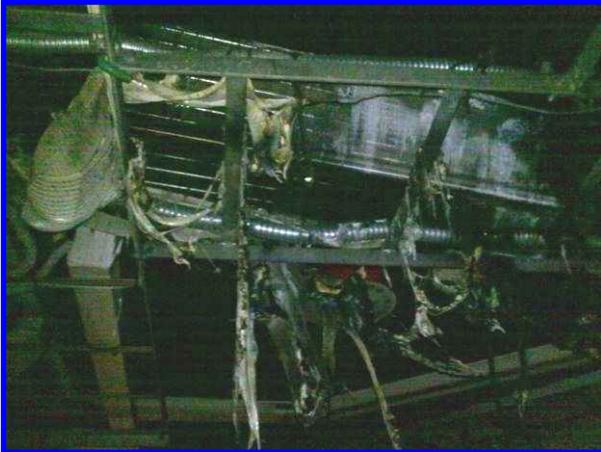
It was also observed that directly below the blower were scorched marks caused by hot molten plastics and metals from the blower unit.

Debris on the floor directly below A/C Blower Unit

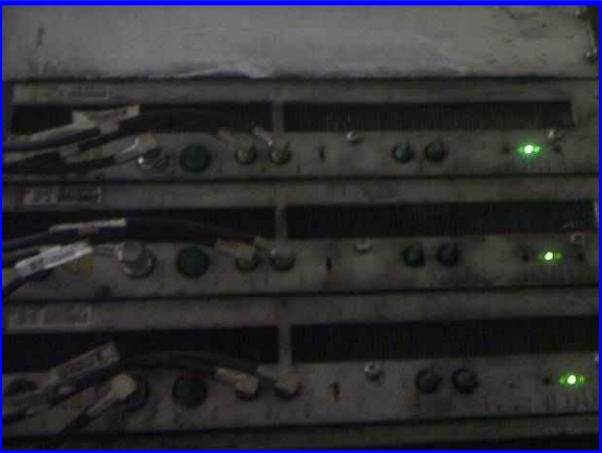
In addition to the blower unit, some interconnecting cables were damaged during the fire. No other equipment within the room was found to be damaged. The mains power supply into the room was interrupted but the telecommunications systems were still operational as the power was switched to the backup battery bank located inside the room.

Communications Equipment powered and working normally

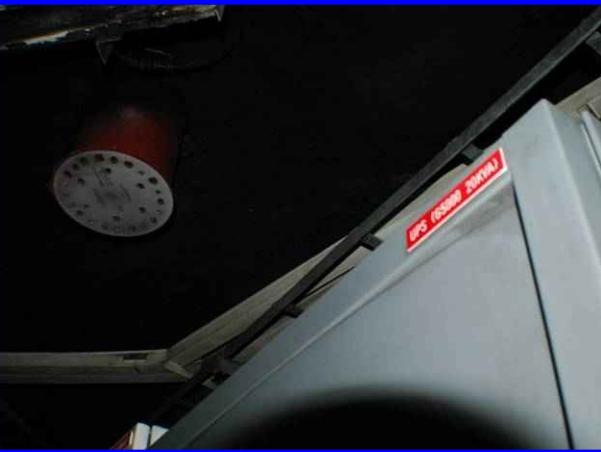
Discharged Pyrogen Generator at the back of the room

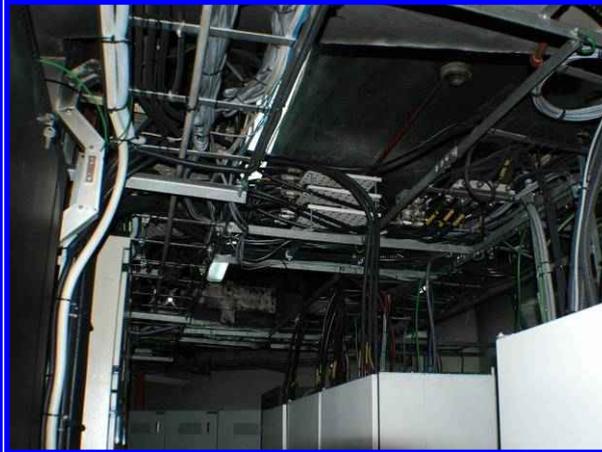
Cable tray at ceiling level

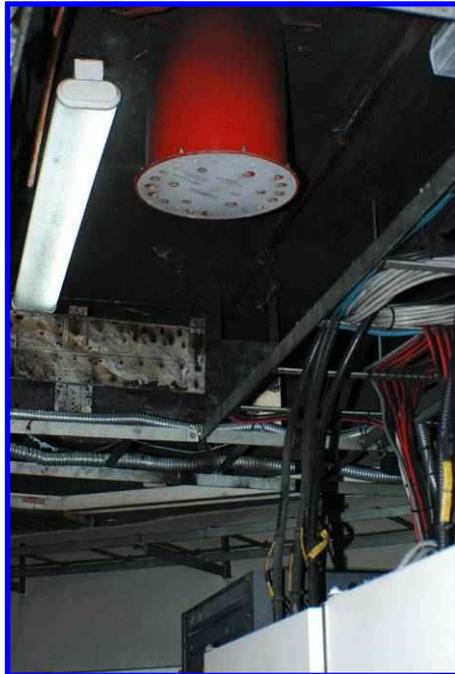
Discharged Pyrogen Generator  
in front of failed A/C unit

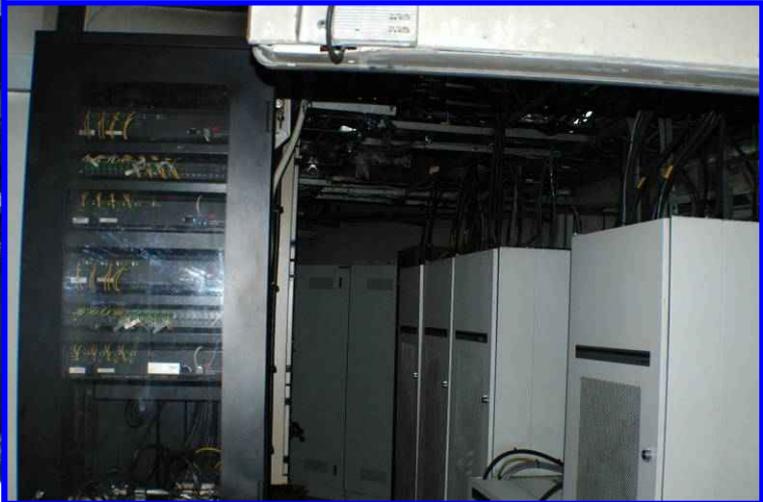
View from the front door of the room

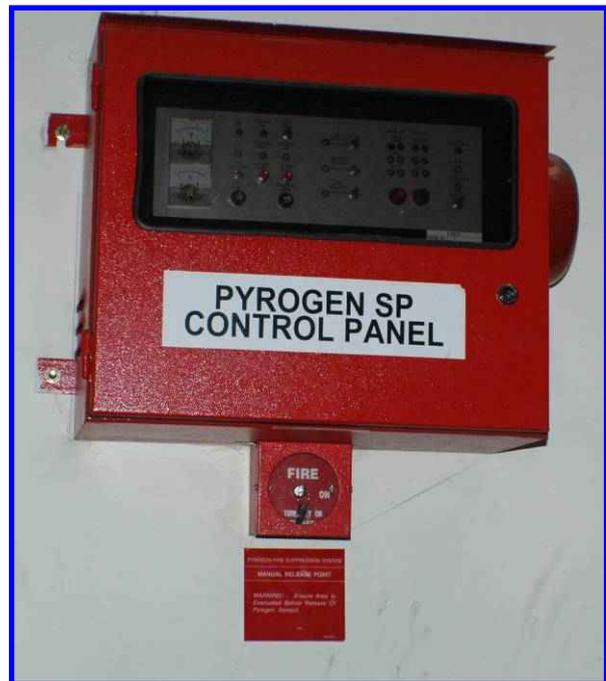
Pyrogen Alarm and Discharge Control  
Panel with bell and manual keyswitch  
and signage
