PYROGEN CORPORATION SDN. BHD. 356066 K
No. 1, Jalan Mokara, 31/62, Kota Kemuning, Section 31, 40640
Shah Alam, Malaysia. Tel. : 603-5219228 Fax. : 603-5219226

INCIDENT REPORT FORM

IR NO.: 01-0015

Pyrogen Fire Suppression System installed in the engine compartment of one, PK30 patrol boat, and its affected engine compartment.

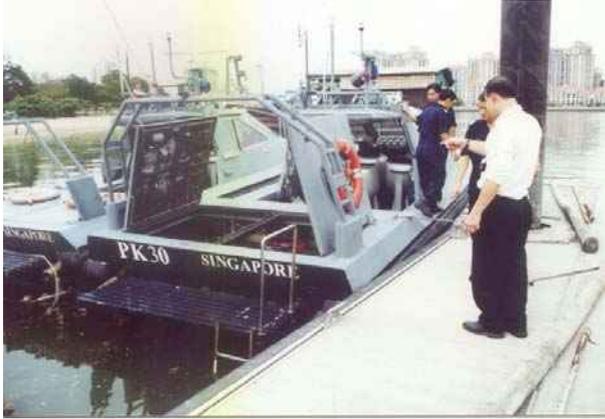
Picture A: External view, of the PK30 patrol boat. Note the open hatch cover of the engine compartment

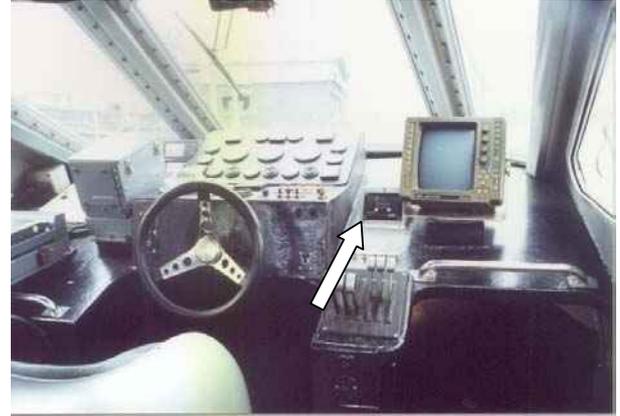
Picture B: Layout of the bridge, note the Fire Mermaid Control Panel (arrow)

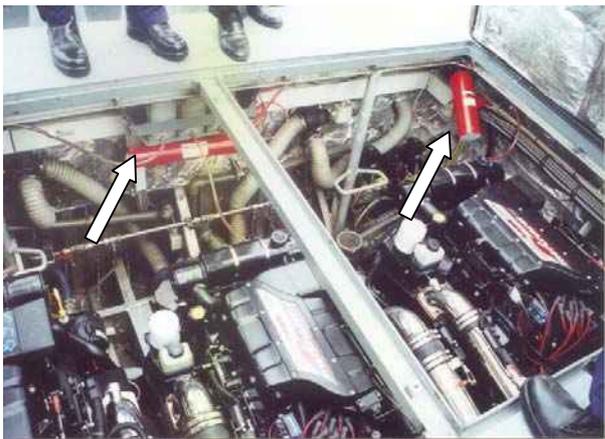
Picture C: Two of the three installed MAG-5 generators, as shown in this engine compartment of a similar unaffected boat

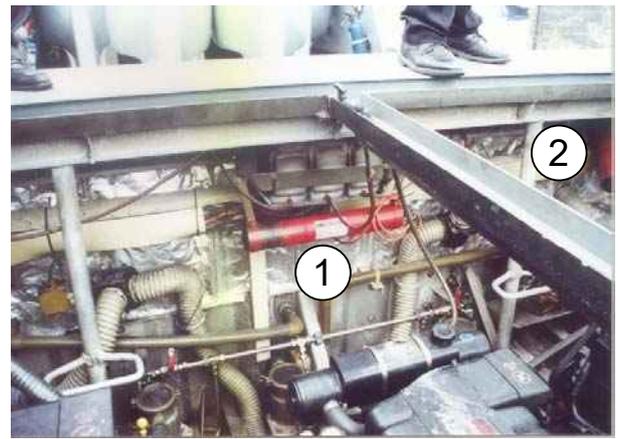
All three Pyrogen canisters were successfully activated (Picture D &

Picture D: The discharged units at the PK30 patrol boat.
 □ : MAG-5 bi-directional
 □ : MAG-5 mono-directional, partly hidden

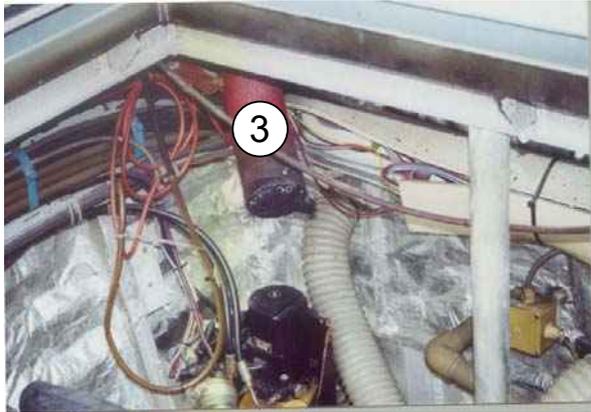
Picture E: The discharged MAG-5 mono-directional, [redacted], at the front corner of the port side engine compartment

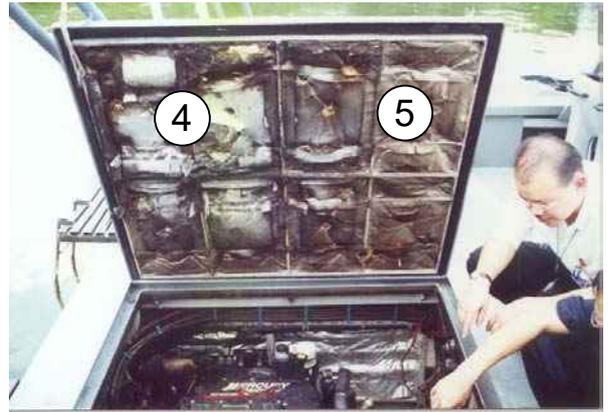
The pattern of heat damage on the top cover confirms the bellow effect of the operating engine with severe damage seen towards the back end (Picture F□), but not towards the front (Picture F, □). Heat damage on the top cover spanned a greater area due to the natural buoyancy of heated air from the fire.

Picture F: The hatch cover, note the burnt area to the left, [redacted]

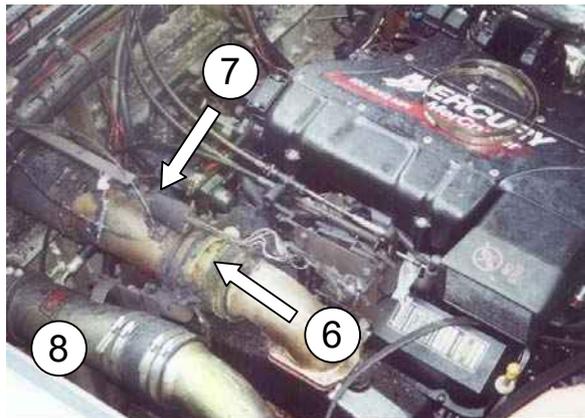
Overheating of the port side engine had caused the temperature at the outlet manifold to increase past the flash point of the rubber seal band (Picture G, □) and caused the band to combust & disintegrate.

The combustion process had been hastened to a great extent and projected into the back end of the compartment by the bellowing effect of the turbo (without the band to direct the air out through the exhaust manifold, it took the shortest path into the engine compartment) before the engine could be switched off. This is in contrast with the barely noticeable effect of the fire to either side of the affected rubber seal band. The adjacent engine's band (Picture G, □) was barely 4 inches away from the side of the combusting band and was unaffected whereas the back wall & cables which were at least one and a half feet away (1½ ') suffered the greatest collateral damage.

It is obvious from the inspection of the Pyrogen Fire Mermaid System's linear heat detector (Picture G,

Picture G: The engine which caught fire, note the burnt rubber seal band around the exhaust manifold, [redacted]

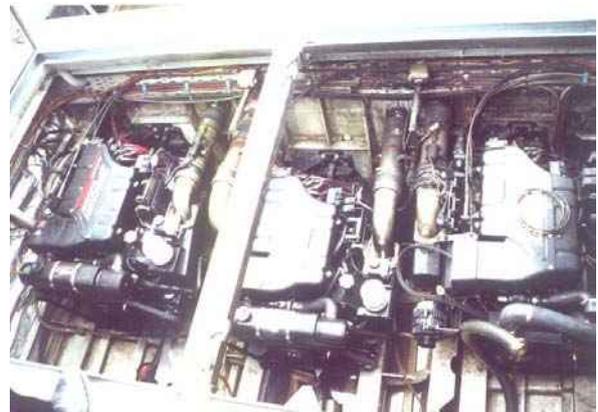
Picture H: The arrangement of the three engines, the affected engine is at the right
