***Brisbane Transport
Pyrogen IPEX Fire Suppression System
Full-Scale Bus Engine
Compartment Fire Test***

Test Report

Volvo MK2 Bus - Middle Engine Compartment

Test Report Ref. No: PGAus: 1/10

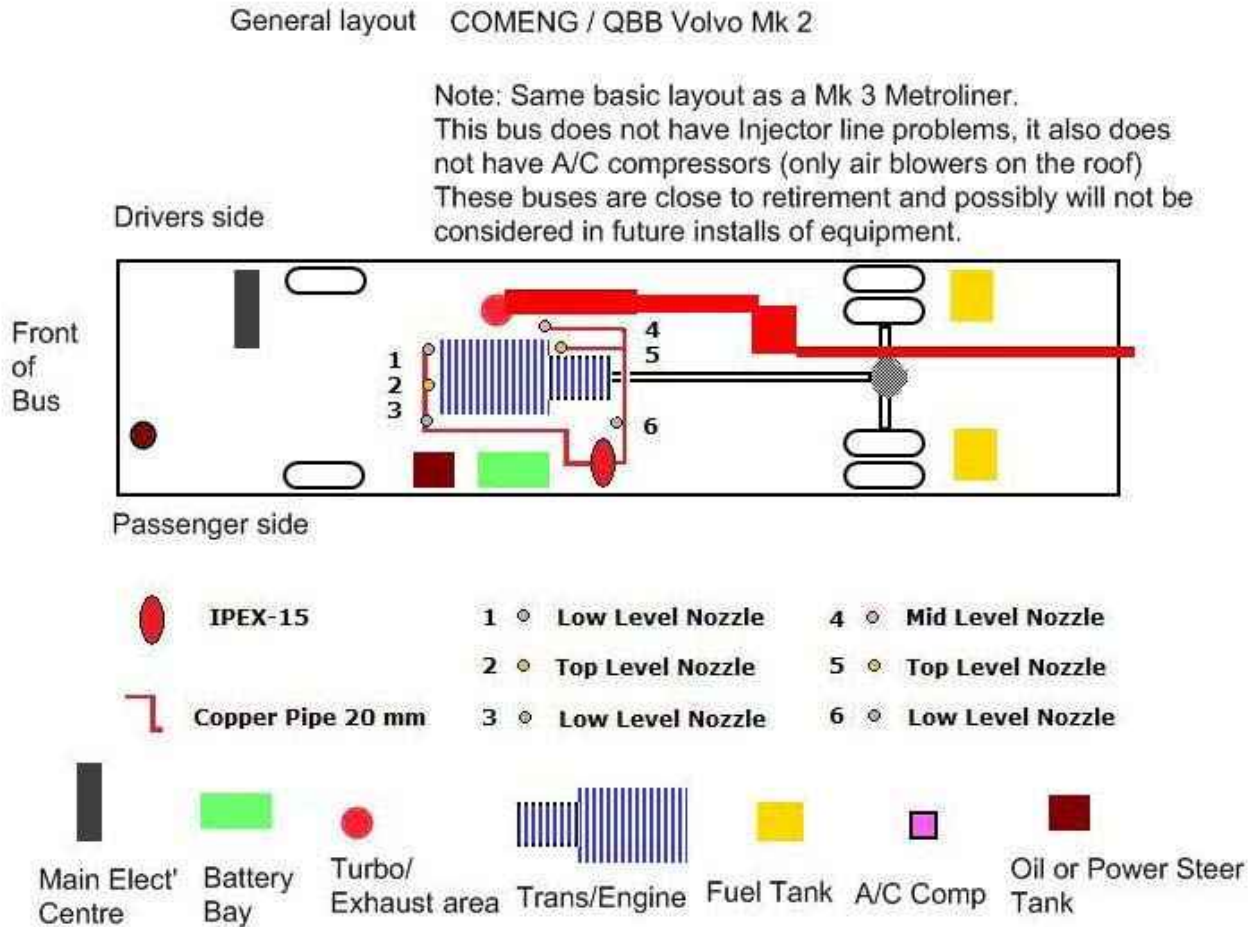
IPEX system consisted of 1IPEX-15T module equipped with 6 nozzles to provide an adequate coverage for all three sections of the engine compartment.

A schematic of the engine compartment and IPEX-15T system layout is shown below in Fig.1

The proposed IPEX engineered system has been specifically designed for a **COMPLETE** protection - both engine compartment (engine fires) and a ground area underneath the engine (spillage fires).

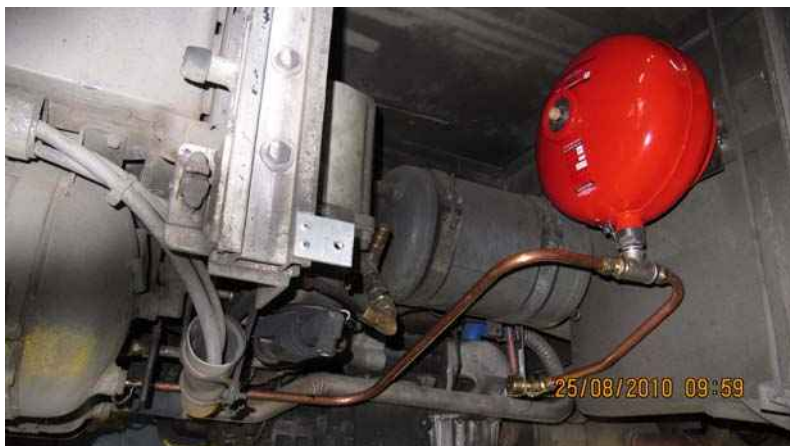
7.1 Layout of Pyrogen IPEX-15T module prior to test

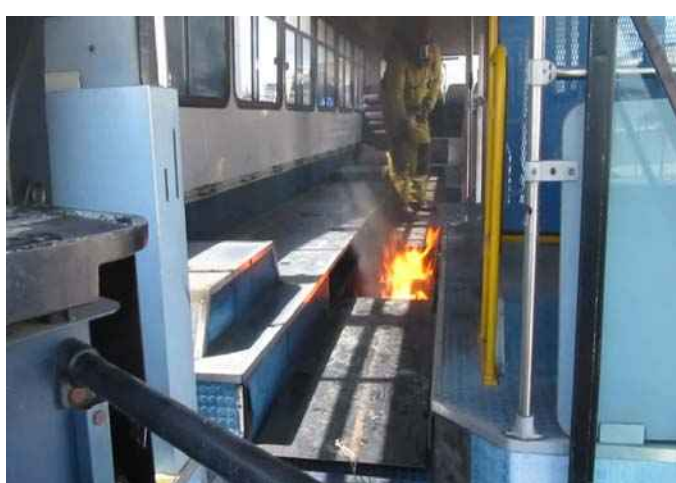
7.2 Top Fire – Engine Compartment

7.2.1 Ignition of Fire Load

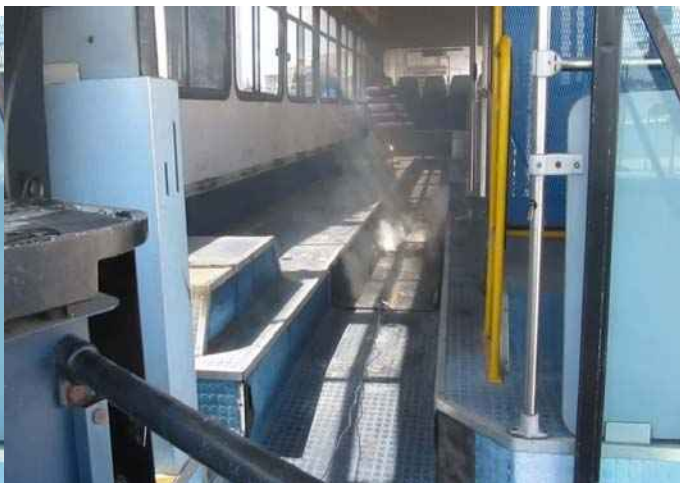
7.2.2 IPEX Activation

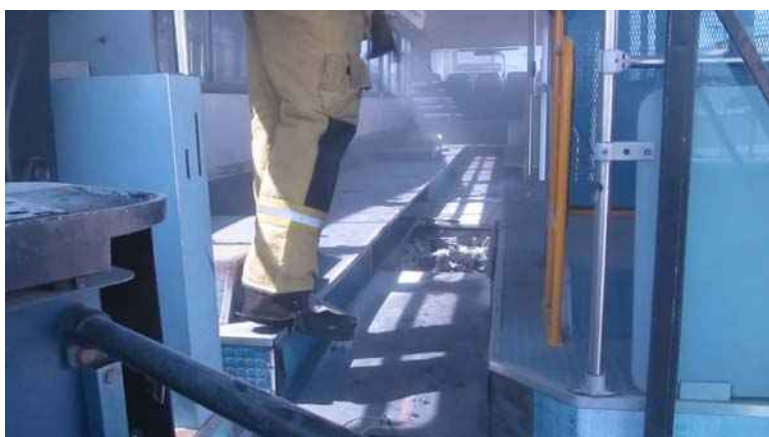
7.2.3 Engine Compartment opened at 1.5 min after the end of IPEX discharge

The visual observation of the Top (Engine) Fire (no video recording in the engine compartment) revealed a complete extinguishment of fire when the engine compartment was opened at 1.5 min after the end of IPEX system discharge.

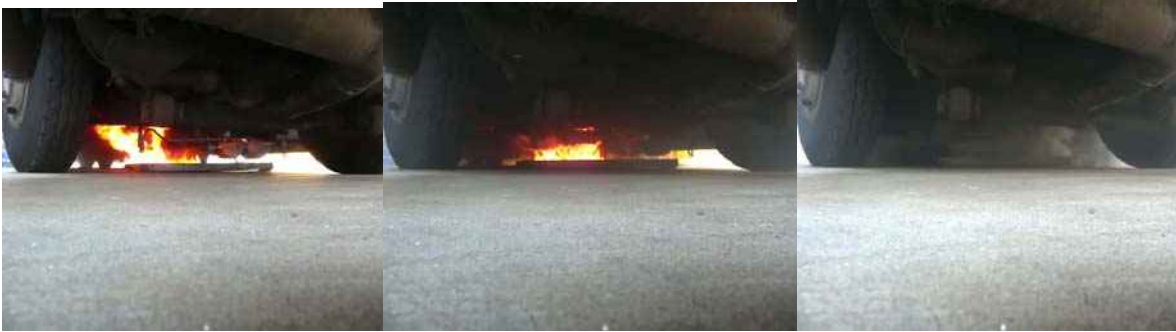
7.3 Bottom Fire – “Spillage Fire” Underneath the Engine

7.3.1 Pre-burn

7.3.2 IPEX Activation,
Commencement of Discharge

7.3.3 Fire Extinguished Prior to end of
IPEX discharge

The video recorded results on Bottom (Spillage) Fire show that the fire had been completely extinguished even prior to the end of IPEX system discharge within just 4 seconds from IPEX system activation.

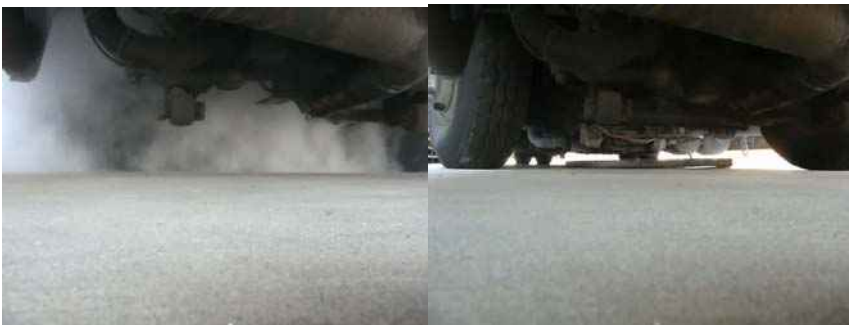
7.3.4 End of IPEX discharge

7.3.5 Post Extinguishment -
15 s after the end of IPEX discharge
